BULLETIN No. 149-67

PROJECT LEVEE
MAINTENANCE AND REPAIR

1967 INSPECTION REPORT

APRIL 1968

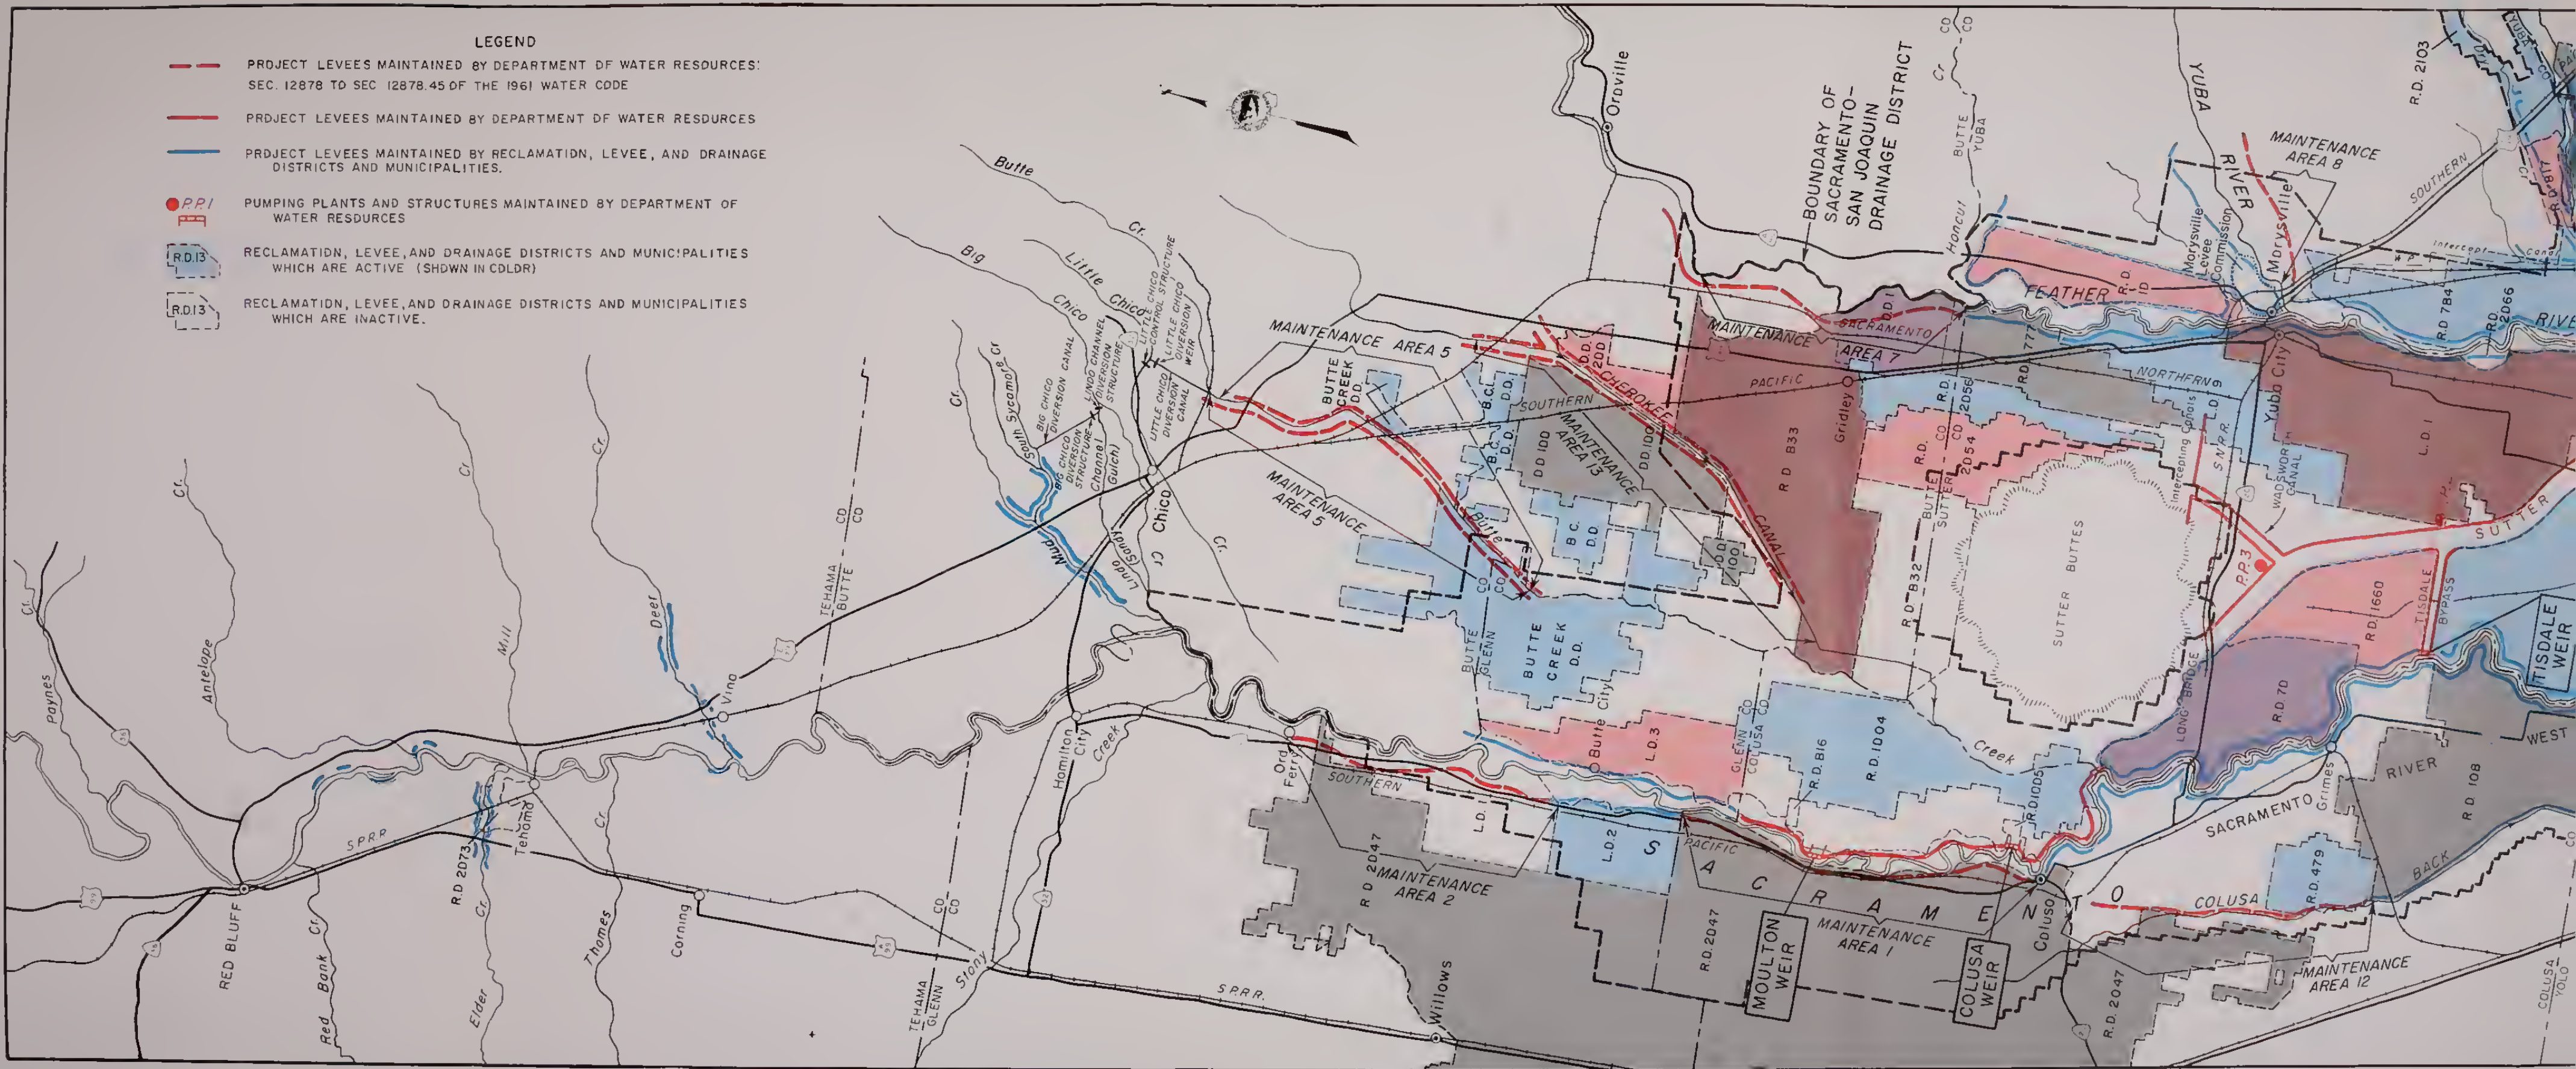
SACRAMENTO RIVER FLOOD CONTROL PROJECT
PROJECT FEATURES AND AGENCIES
1967

- PROJECT LEVEES MAINTAINED BY DEPARTMENT OF WATER RESOURCES:
SEC. 12878 TO SEC. 12878.45 OF THE 1961 WATER CODE
- PROJECT LEVEES MAINTAINED BY DEPARTMENT OF WATER RESOURCES
- PROJECT LEVEES MAINTAINED BY RECLAMATION, LEVEE, AND DRAINAGE DISTRICTS AND MUNICIPALITIES.
- PUMPING PLANTS AND STRUCTURES MAINTAINED BY DEPARTMENT OF WATER RESOURCES
- RECLAMATION, LEVEE, AND DRAINAGE DISTRICTS AND MUNICIPALITIES WHICH ARE ACTIVE (SHOWN IN COLOR)
- RECLAMATION, LEVEE, AND DRAINAGE DISTRICTS AND MUNICIPALITIES WHICH ARE INACTIVE.
